Quality Assurance and Source Inspection

Contract #: 04-0120F4Cty: SF/ALA Rte: 80 PM: 13.2/13.9File #: 69.28**WELDING INSPECTION REPORT****Resident Engineer:** Pursell, Gary**Address:** 333 Burma Road**City:** Oakland, CA 94607**Report No:** WIR-000378**Date Inspected:** 23-Aug-2007**Project Name:** SAS Superstructure**OSM Arrival Time:** 1400**Prime Contractor:** American Bridge/Fluor Enterprises, a JV**OSM Departure Time:** 2000**Contractor:** Zhenhua Port Machinery Company, Ltd (ZPMC), Changxing Island **Location:** Shanghai, China**CWI Name:** Hou jing yao**CWI Present:** Yes No**Inspected CWI report:** Yes No N/A**Rod Oven in Use:** Yes No N/A**Electrode to specification:** Yes No N/A**Weld Procedures Followed:** Yes No N/A**Qualified Welders:** Yes No N/A**Verified Joint Fit-up:** Yes No N/A**Approved Drawings:** Yes No N/A**Approved WPS:** Yes No N/A**Delayed / Cancelled:** Yes No N/A**Bridge No:** 34-0006**Component:** Mock-Up 77.00**Summary of Items Observed:**

Caltrans Quality Assurance (QA) Inspector, Mike Hasler was present to observe the fitup and welding of the Caltrans Mock-up #77.00, for the San Francisco Oakland Bay Self Anchored Suspension Bridge, at Zhenhua Port

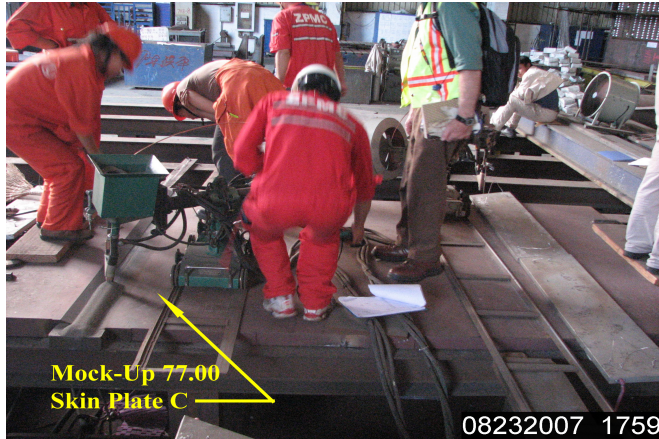
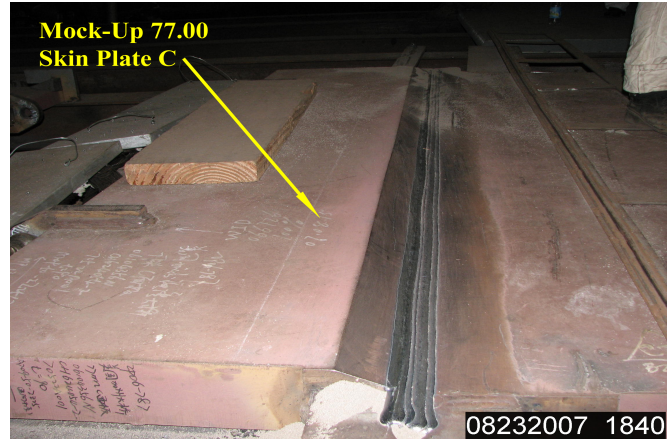
Caltrans QA Inspector observed submerged arc welding (SAW) in progress at skin plate C, piecemark mp13 to MA4, inside side. The in process subassembly fabrication, appears to be at step 6.1 in regards to the mock-up fabrication procedure flow plan. The weld joint is identified as a double vee butt joint with a partial joint penetration weld. The welder operator is identified as Ms. Shen Mei. The approved welder is observed welding the partial joint penetration (PJP) weld cover pass, in the flat position. The welder is using welding procedure specification (WPS), WPS-B-T-2321-B-P3-S, Revision 0. Caltrans QA Inspector measured the operating welding parameters at approximately 690 amps, 34.0 volts, 612 millimeters per minute (mm/min) travel speed. Preheat and interpass temperatures were verified during welding activities. Preheat temperature prior to the start of welding, measured more than 110 Celsius (230 degree Fahrenheit) but less than 232 Celsius (450 degrees Fahrenheit) during maximum interpass temperature verification. Following digital picture illustrates welding in progress and, completed cover pass weld.
